DEPARTMENT OF TRANSPORTATION**DIVISION OF ENGINEERING SERVICES**

Contract #: 04-0120F4Cty: SF/ALA Rte: 80 PM: 13.9/14.3,0.0/1.6File #: 69.28**WELDING INSPECTION REPORT****Resident Engineer:** Pursell, Gary**Address:** 333 Burma Road**City:** Oakland, CA 94607**Report No:** WIR-000839**Date Inspected:** 14-Nov-2007**Project Name:** SAS Superstructure**OSM Arrival Time:** 2300**Prime Contractor:** American Bridge/Fluor Enterprises, a JV**OSM Departure Time:** 730**Contractor:** Zhenhua Port Machinery Company, Ltd (ZPMC), Changxing Island **Location:** Shanghai, China**CWI Name:** Sha Zhi & Hua Li Wen**CWI Present:** Yes No**Inspected CWI report:** Yes No N/A**Rod Oven in Use:** Yes No N/A**Electrode to specification:** Yes No N/A**Weld Procedures Followed:** Yes No N/A**Qualified Welders:** Yes No N/A**Verified Joint Fit-up:** Yes No N/A**Approved Drawings:** Yes No N/A**Approved WPS:** Yes No N/A**Delayed / Cancelled:** Yes No N/A**Bridge No:** 34-0006**Component:** Caltrans Mock-Up & OBG Fab.**Summary of Items Observed:**

Caltrans Quality Assurance (QA) Inspector, Mike Hasler was present to observe the fitup, welding and related activities associated with the fabricating of Caltr

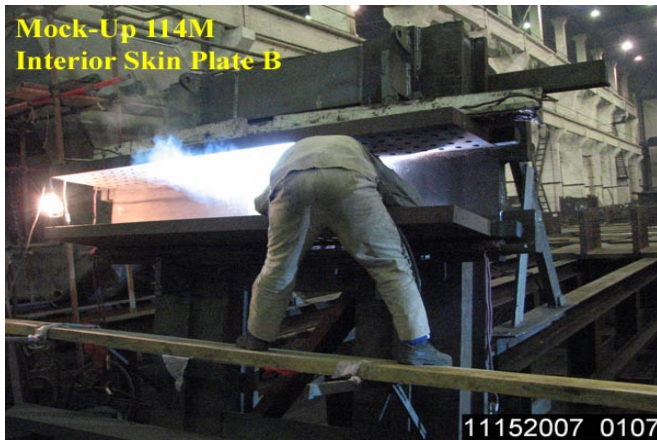
Mock-Up 114M, Interior Skin Plate B: Caltrans QA Inspector observed flux cored arc welding (FCAW), complete joint penetration (CJP) weld, longitudinal stiffener plate p920, joining skin plate A65, weld #1, fill pass weld in the flat position. The welder is identified as Mr. Bai Wenming, welder stamp 040434. The welder is using welding procedure specification WPS-B-T-2231-TC-U5-F, Revision 1. Caltrans QA observed ZPMC Quality Control inspector, Mr. Sha Zhi and Bureau Veritas (BV) inspector, Mr. Hua Li Wen, monitoring welding activities at the workstation. Caltrans QA Inspector measured current welding parameters at approximately 295 amps, 31.4 volts and 330 millimeters per minute (mm/min) travel speed. Preheat and interpass temperatures were verified during welding activities. The preheat temperature prior to the start of welding measures more than 110 Celsius (230 degree Fahrenheit) but less than 232 Celsius (450 degrees Fahrenheit) during maximum interpass temperature verification. FCAW welding consumable is verified and identified as Supercored 71H, classification E71T-1, diameter 1.4 mm (.055 inches). The following digital picture illustrates welding in progress.

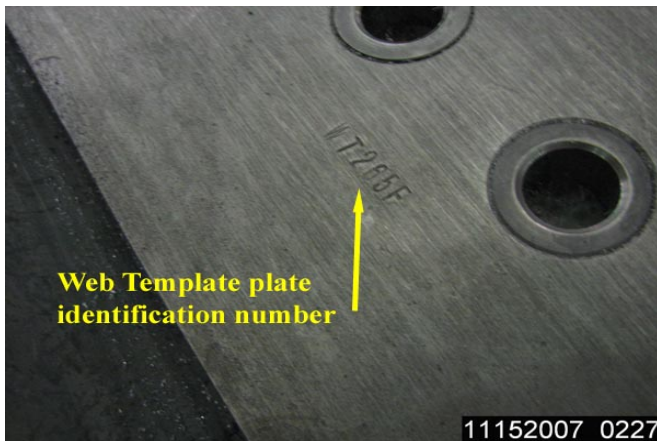
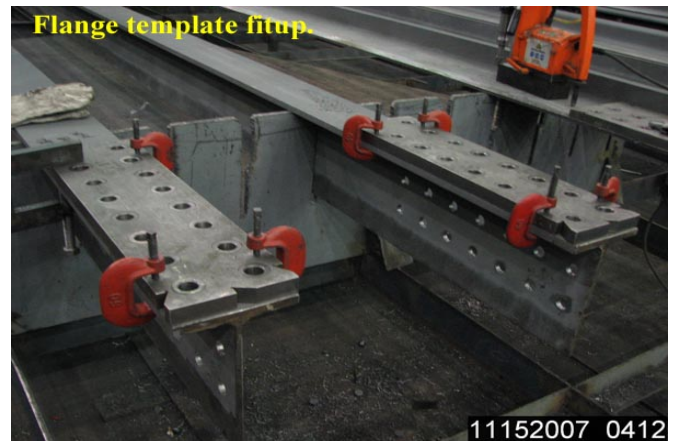
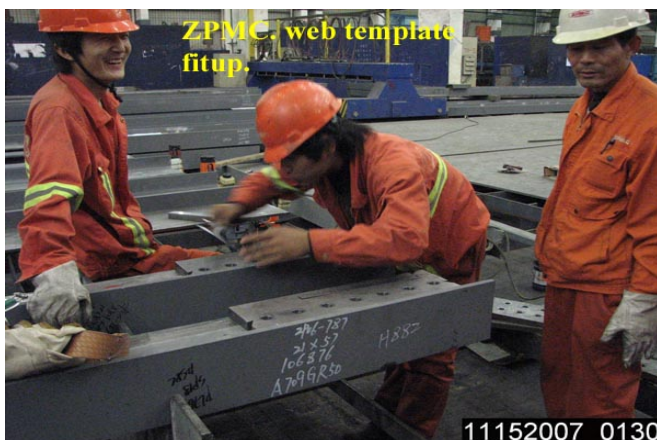
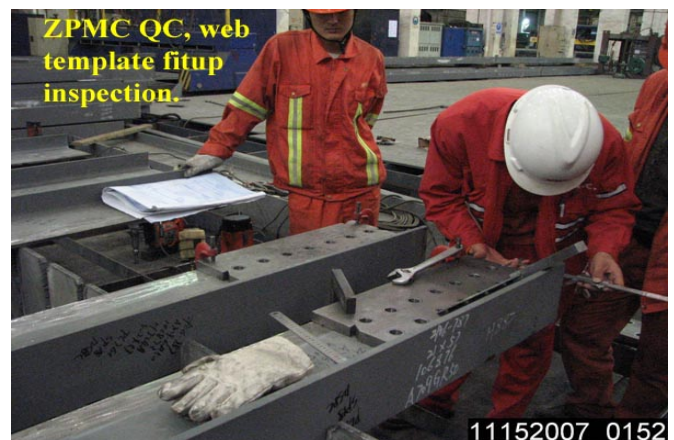
- 2 OBG Split Tee NA NA Drill Bolt Holes
- OBG Building #2; Caltrans QA Inspector observed ZPMC shop personal match drilling, split tee, bolt hole connections, at the web and flange. The two tee assemblies being drilled were identified as RS8C, PL76C.
- Caltrans QA Inspector observed template plates attached to the web and flange and held in place with clamps. The template plate for the web is identified as WT265F and WT265Y, flange.
- ZPMC QC inspector, Mr. Wang Xiang Pin verified template fitup, in accordance with the shop drawings requirements, prior to the drilling of the bolt holes and appeared to be in conformance with the project specifications. The following pictures illustrate the drilling of the bolt connections.
